HISTORIC STRUCTURES REPORT

OLD NORTH CHURCH

ARCHITECTURAL DATA

BOSTON NATIONAL HISTORICAL PARK

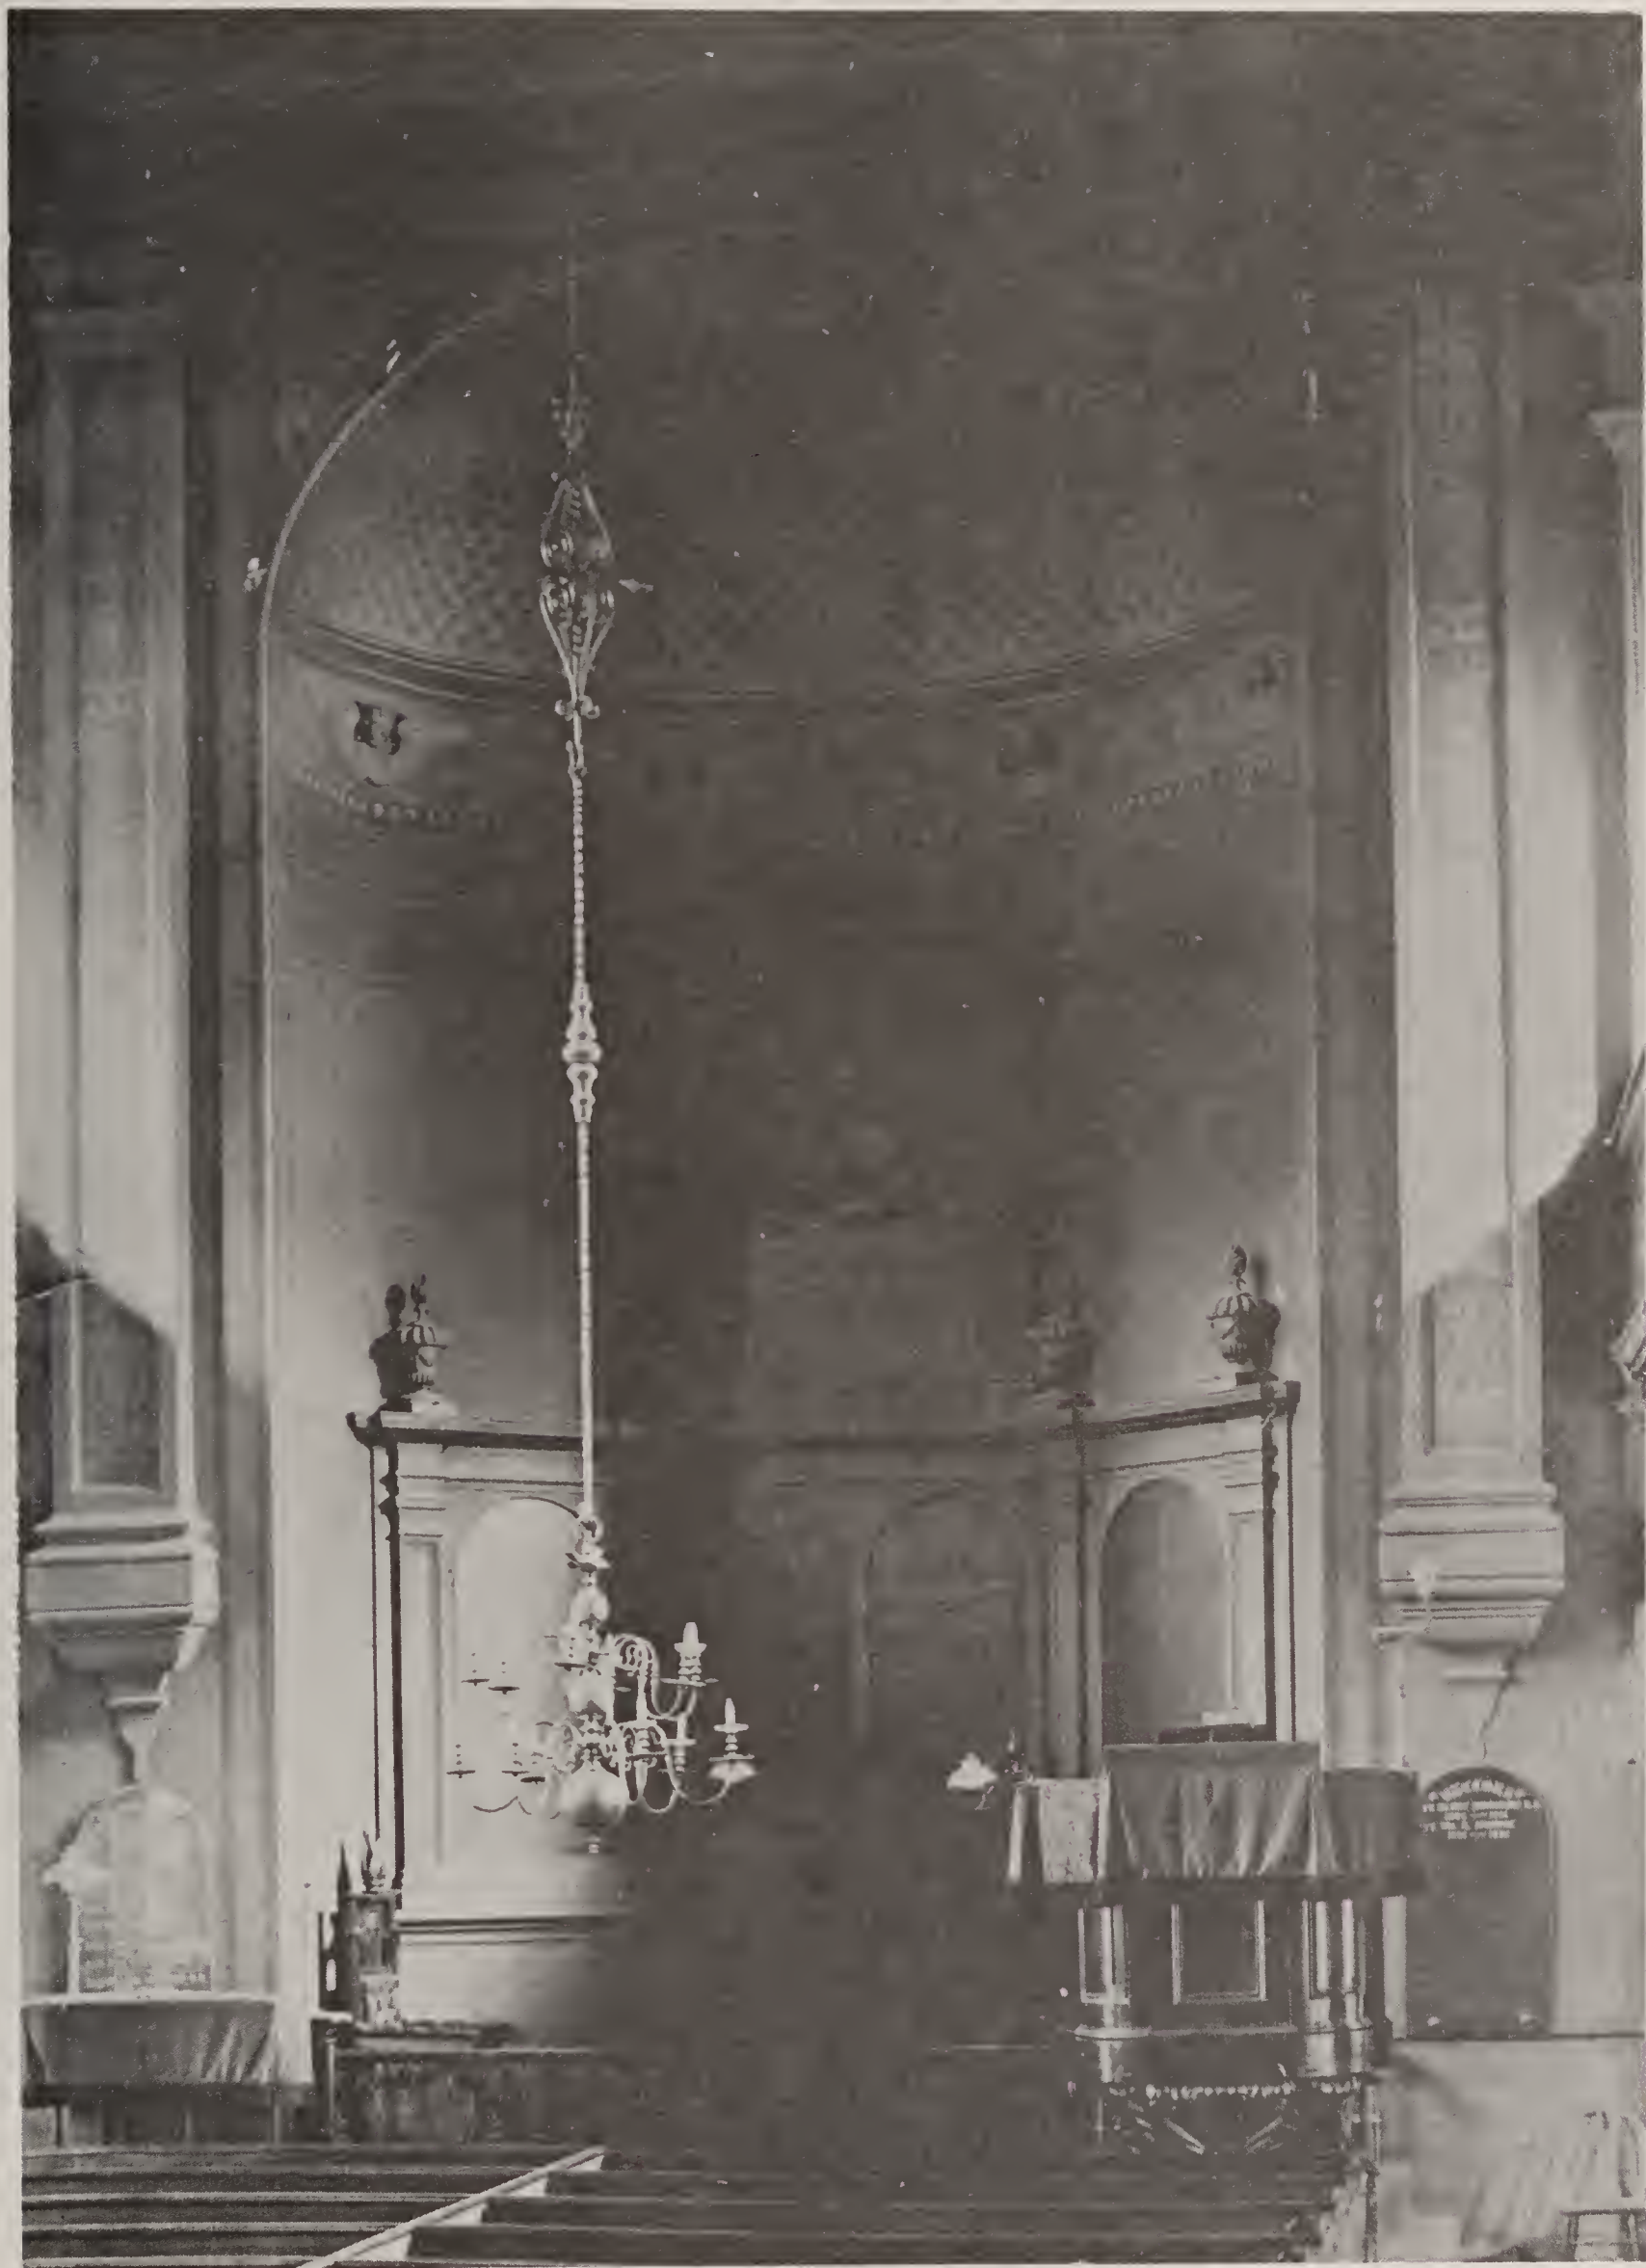
Post-1884 View of Chancel and Southeast Corner of Old North Church

In addition to the excellent view of the 1830 pulpit with an interesting gas light fixture, this photograph shows the following details: the original pilasters under the gallery at the east wall (removed in 1912); the c. 1806 modified pier bases and pedestals (in 1912 these pier bases were retained and an attempt was made to restore the rusticated pedestals); details of the 1806 slip pews; the 1815 Washington Memorial in the closed-up east window opening; and the 1884 gas fixture attached to the pier.

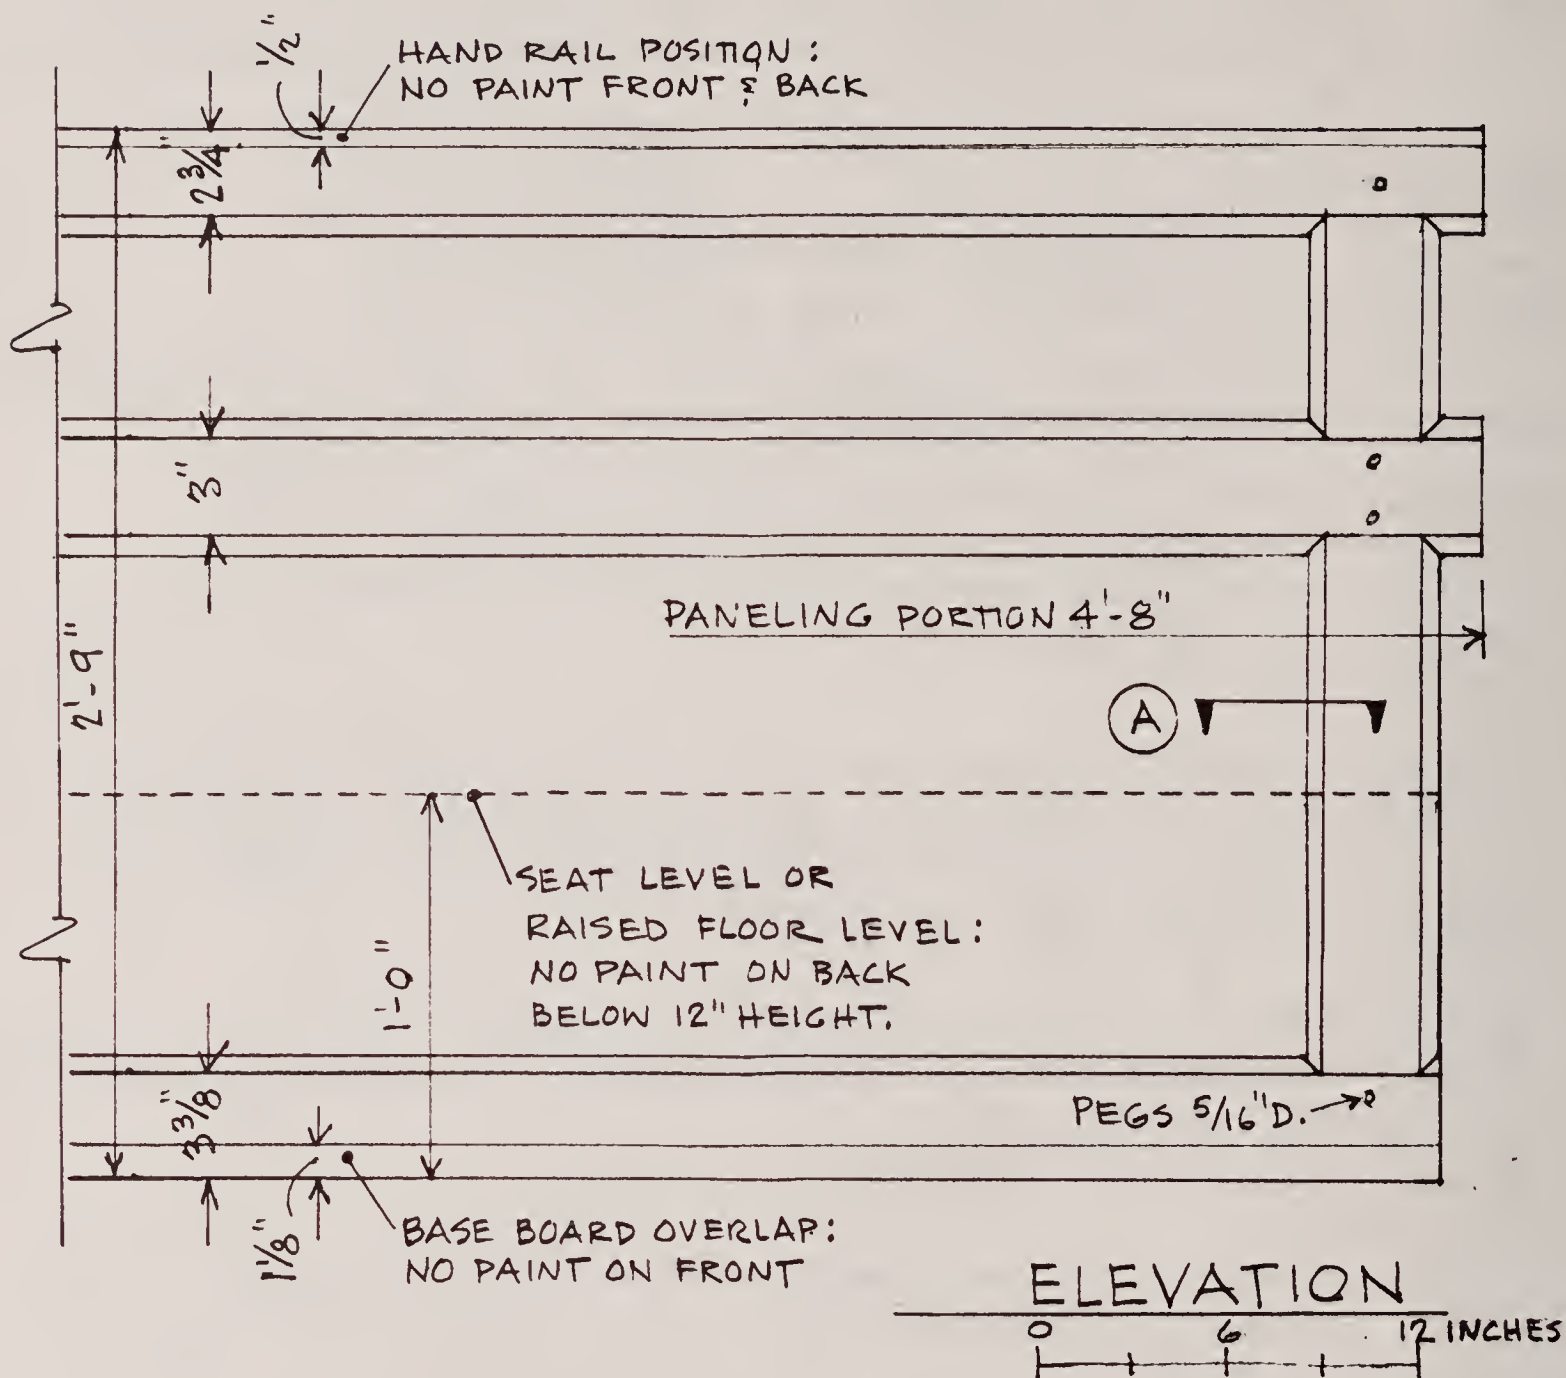
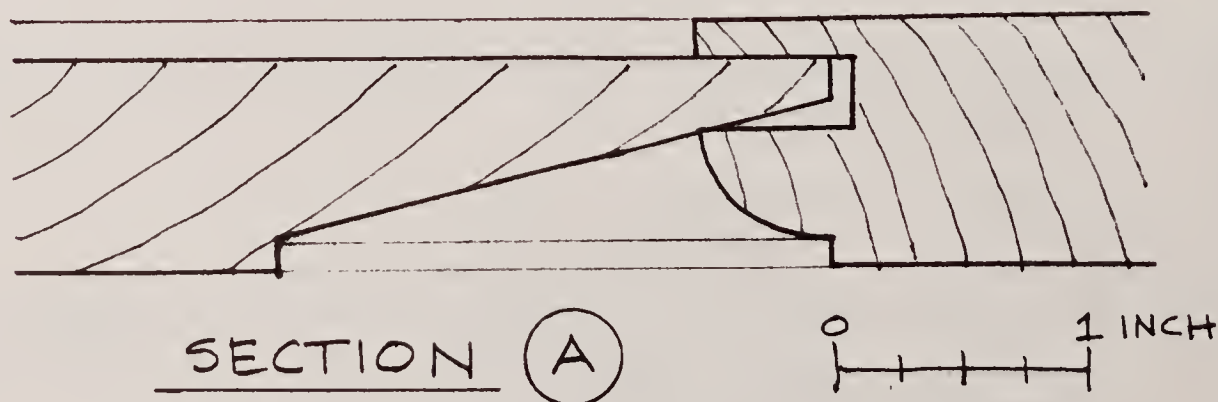
CHRIST CHURCH - "OLD NORTH CHURCH"
 BOSTON - EARLY SECTION OF PANELING FOUND
 APPLIED WITH CUT NAILS (1806?) TO BACK SIDE OF
 (1806?) TOWER VESTIBULE PARTITION - NW CORNER.

PAINT LAYERING FRONT FACE:
 WOOD; 2 FINISH COATS - LIGHT CREAM (MUNSELL 7.5 Y 9 1/2)
 SEPARATED BY SKINS & DIRT ON SURFACE.

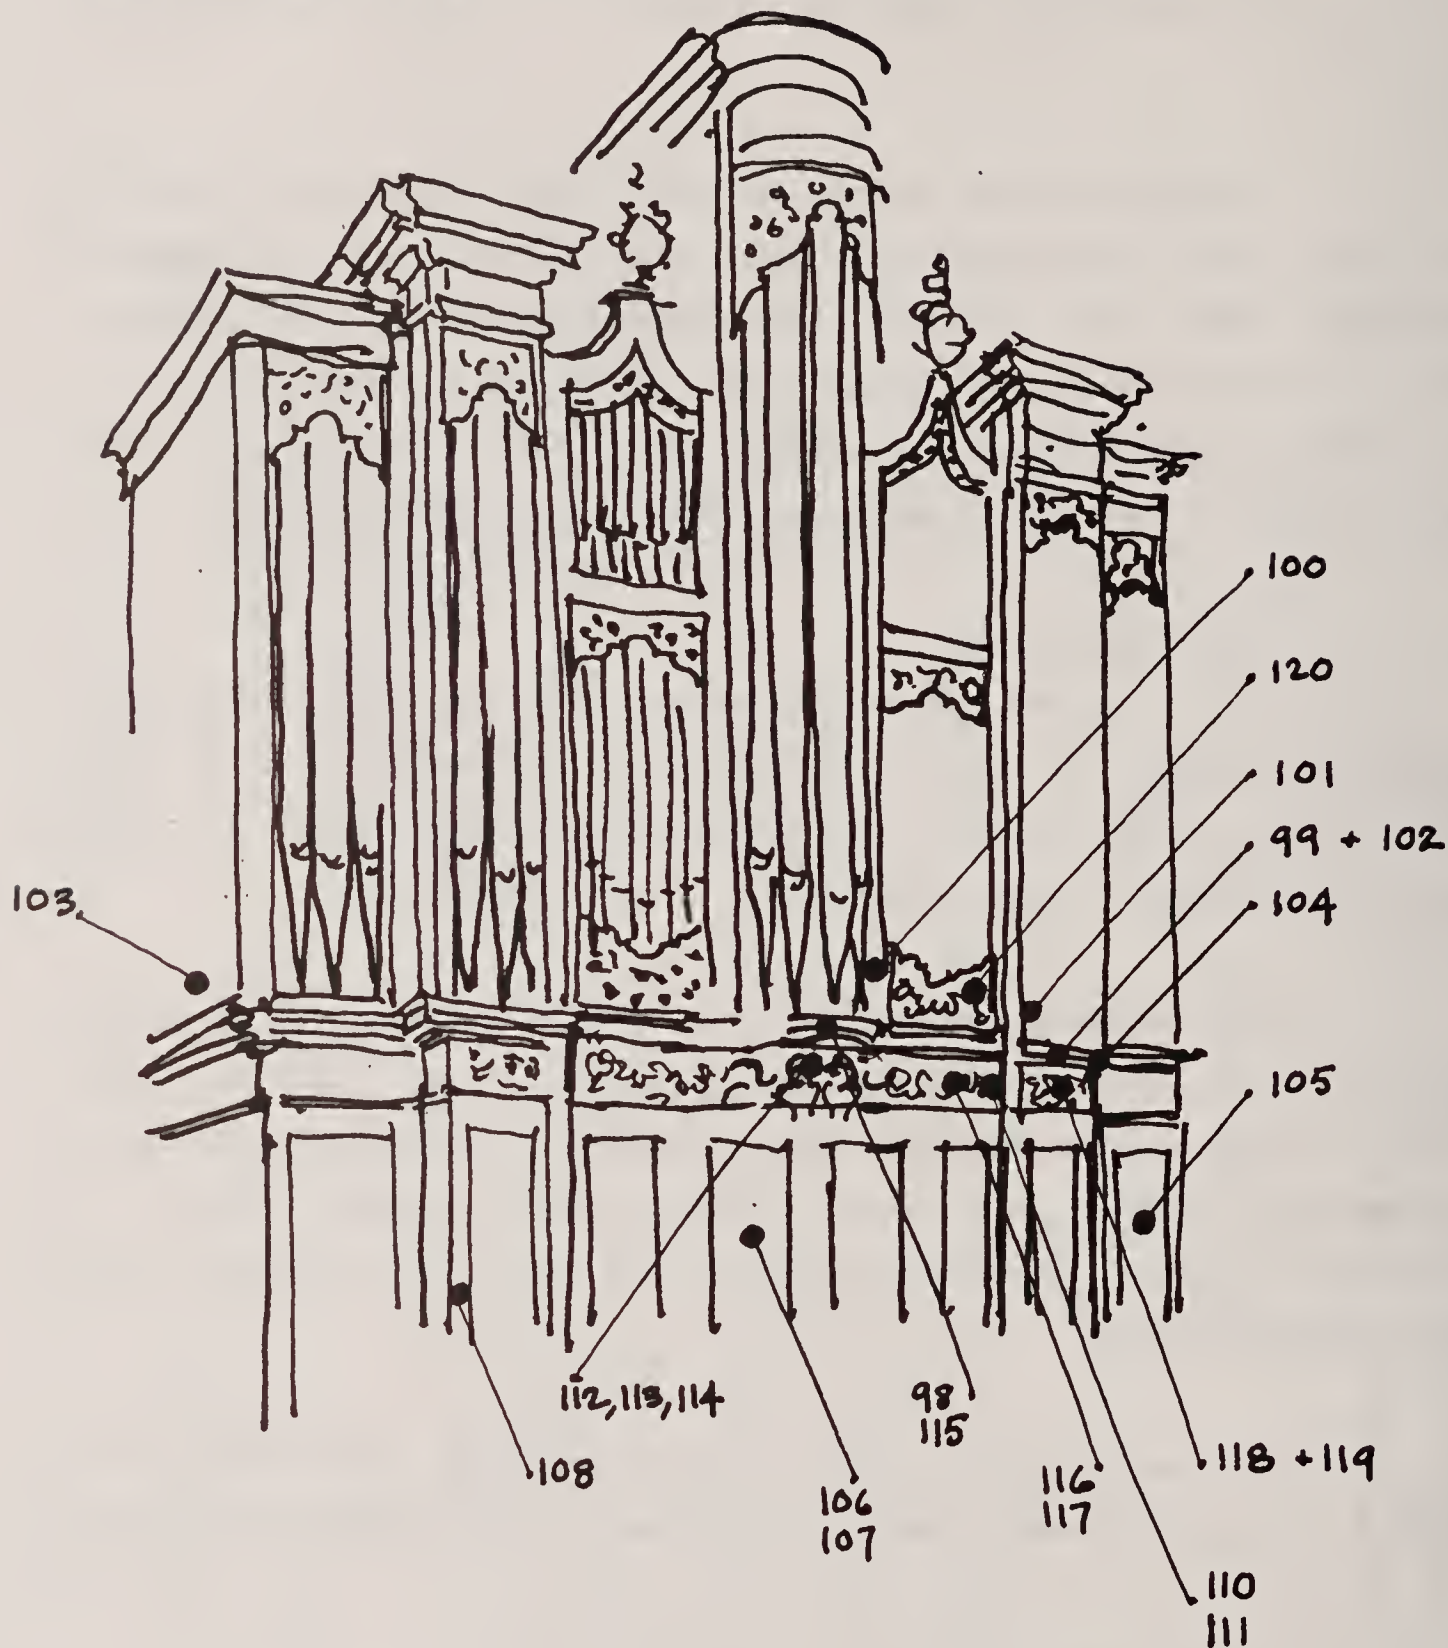
All above samples have same ochre bottom layer, except:
 # 112, 113, 114 from cherub carvings which have bottom layer of dark red bronze graining.
 Do the cherubs date from 1737 organ?
 While all else is 1759 Johnston organ?
 # 103 + 105 have fewer layers as they are from the 1884 additions - compare old photographs pre and post 1884.
 # 110 seems to be of a 1913 repair.

differs. The cherubs were primed with red iron oxide, and for a long period, had a finish coat of dark red brown graining. Could these cherubs possibly date from the first Old North organ of 1737, known as the Claggett organ? Their present placement, although centered prominently, does seem to be rather "pasted" onto the carved leaf frieze. Although Johnston's 1759 painting bill may refer to the carved angles installed in 1746 when it included "By mending the carved figure & new painting them," it could also refer to restoring the carved cherubs for the new organ case.

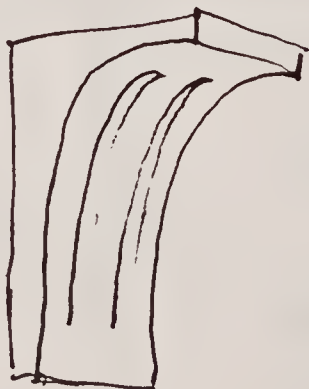
ARCHITECTURAL FEATURE:
Interior face of West Tower Door Frame - South jamb

Note bracket had been fastened with the following:
 4 wire nails still in bracket
 4 nails holes & broken off nails still in back from previous nailing.
